WHITNEY LAKE DAM

NDI ID NO PA-00142

PHASE I INSPECTION REPORT

NATIONAL DAM INSPECTION PROGRAM

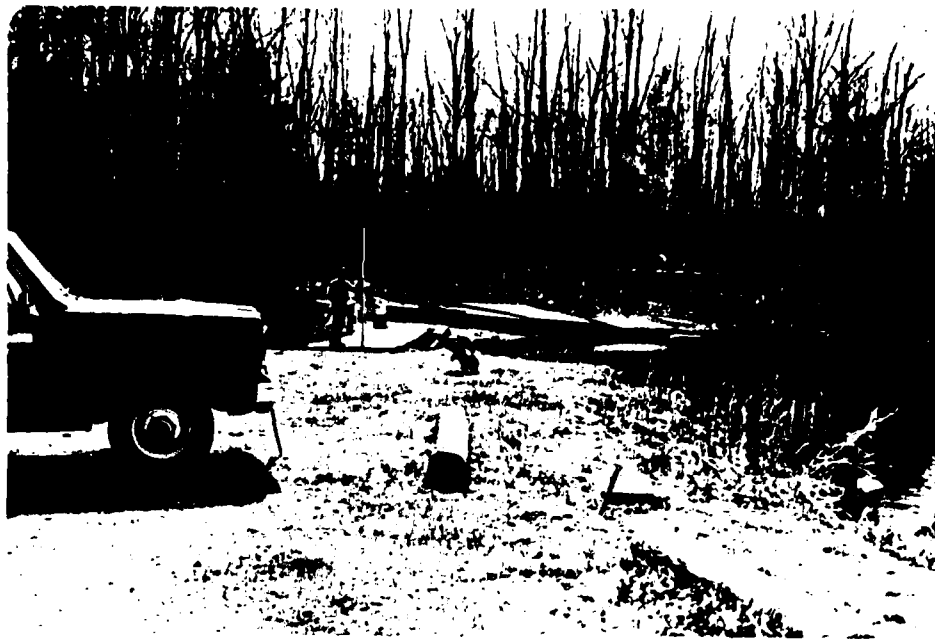
A. Embankment - View From Left Abutment

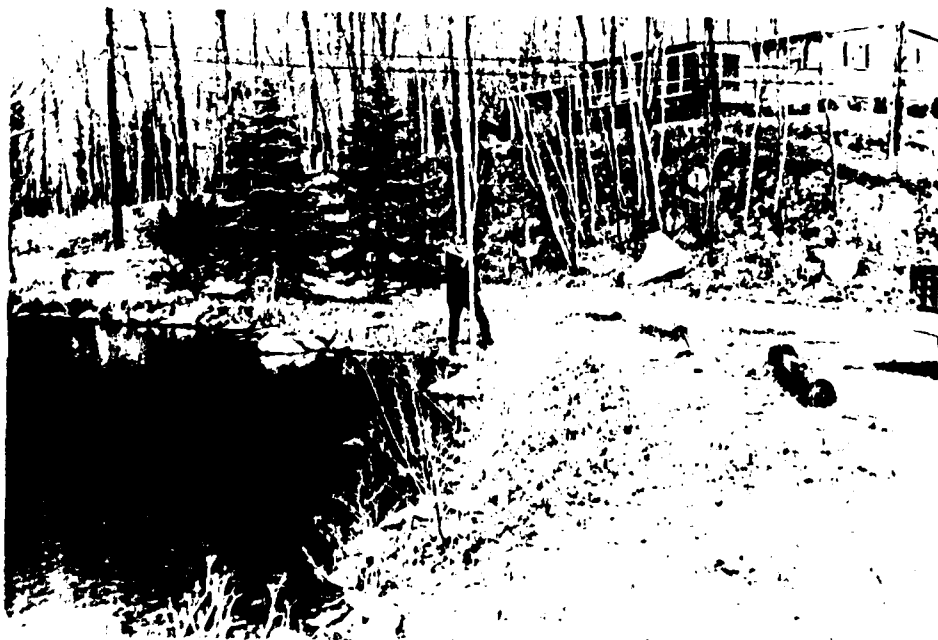
B. Upstream Slope

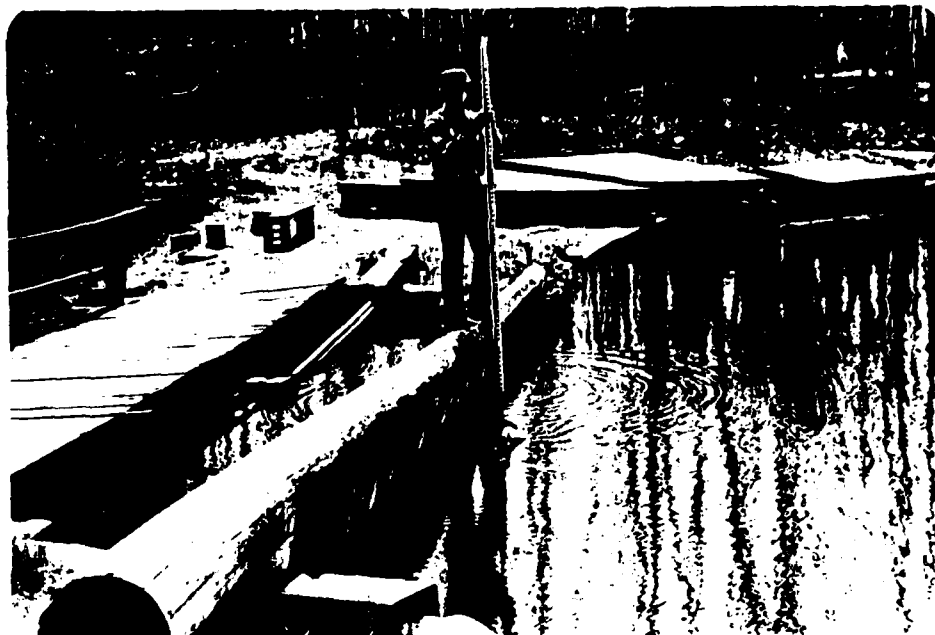
c. Appurtenant Structures. Overall, the spillway is in fair condition. A log trash boom extends across the spillway approach channel (Photograph C). The small, low spillway approach walls are cracked, tilted, and displaced. Stoplogs extend across the spillway crest. The top of the stoplogs is uneven. The concrete spillway walls act as abutments for the timber spillway bridge. The toe of the left spillway wall is deeply scoured. The stone masonry paving of the spillway chute is in relatively good condition, but the mortar of the stone masonry chute walls is severely deteriorated in places. A significant quantity of water was flowing from the spillway chute through the right spillway wall (Photograph D).

C. Spillway Approach

(1) Design and construct a spillway capable of passing a minimum of the 100-year flood. Before this work is accomplished, remove the trash barrier and stoplogs at the spillway so that the spillway capacity is increased during the design period.

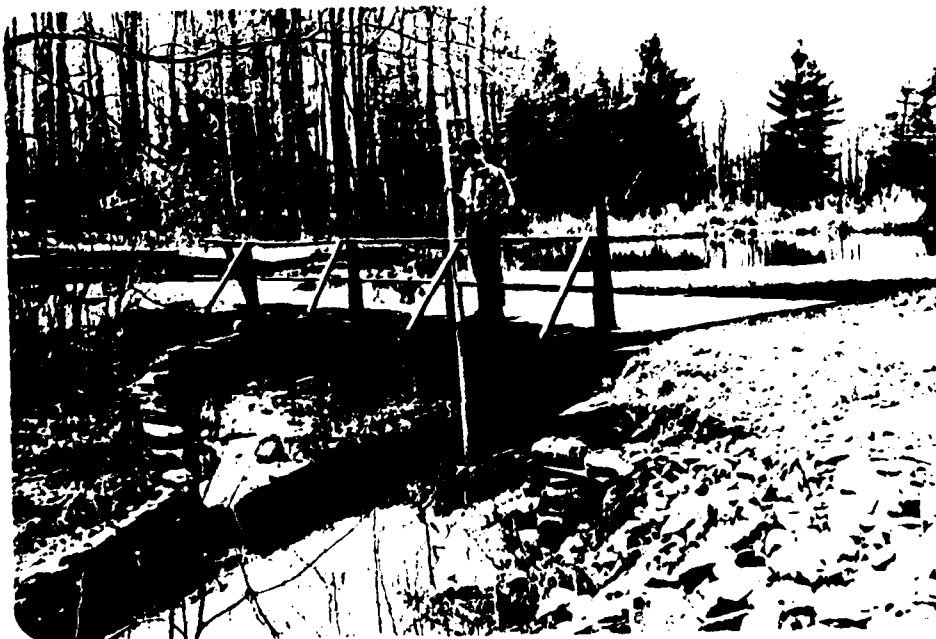
D. Spillway

(3) Monitor the seepage at the toe of the spillway chute. Take appropriate action if any condition worsens.
